# Magnetic Rope Testing

Port of Antwerp/Bruges' Pontoon Crane BRABO

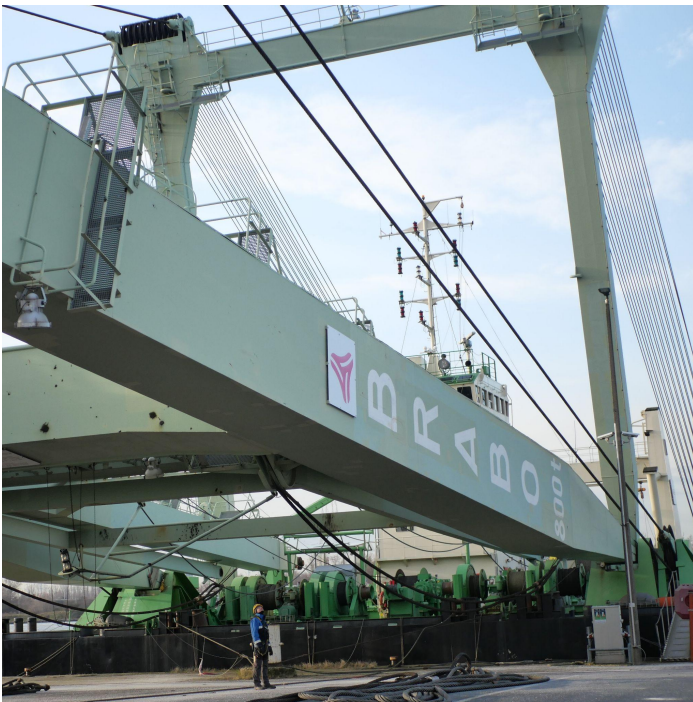
The client desired a comprehensive examination of their crane's boom cables, going beyond the standard visual inspections. Given the crane's height, even when in the lowered position, our team had to operate from an aerial platform. The cable diameter varied from 82mm to 107mm, surpassing the capabilities of most conventional inspection devices.

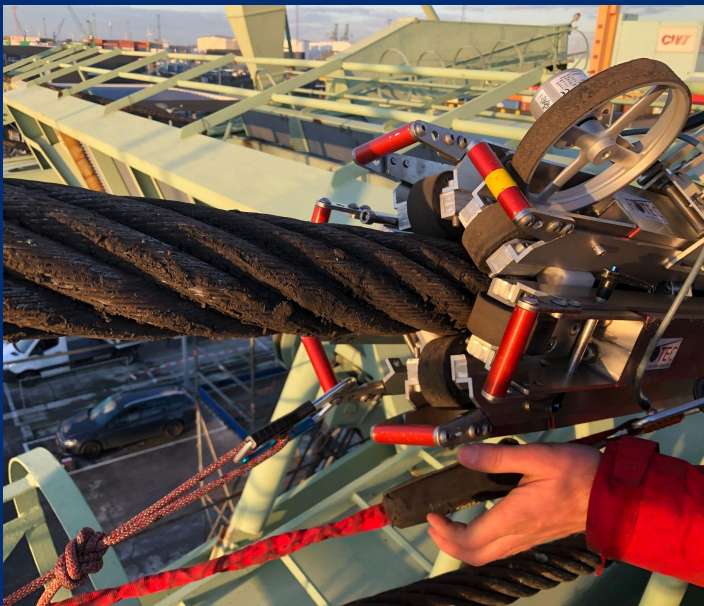
We determined that MRT was the most appropriate non-destructive testing technique. This method involves fully magnetizing a section of the rope and subsequently identifying and measuring alterations in the magnetic field resulting from broken wires, corrosion, wear, or mechanical damage. For this mission we collaborated with Ropesys to deliver the optimal hardware and expertise for the job.

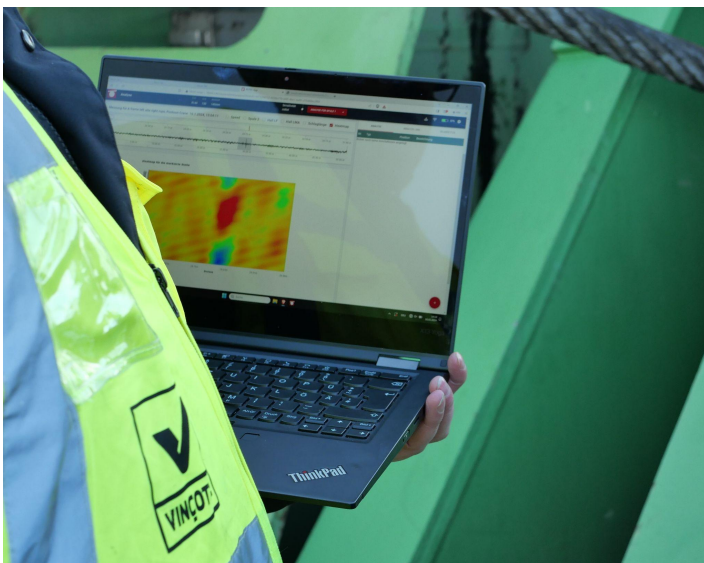
The examination provides the customer with unprecedented insights into the state of their boom cables. Critical areas of concern could be highlighted in a heatmap, offering valuable reference points for future use. This assurance contributes to a sense of security when operating the crane in the years ahead.

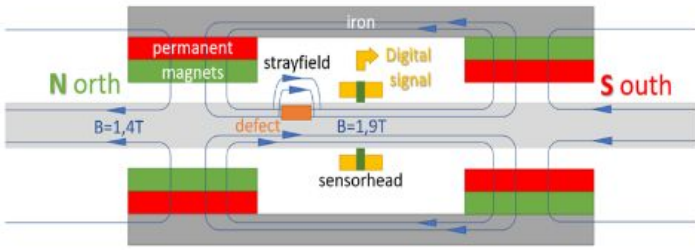
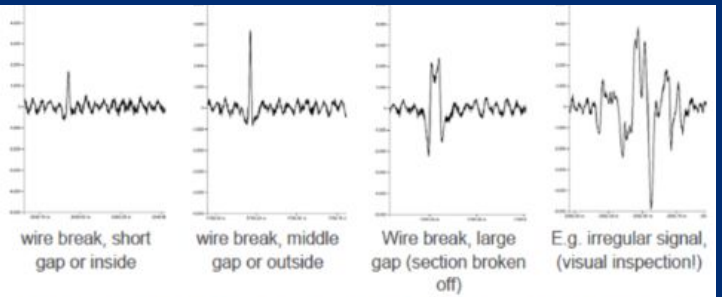
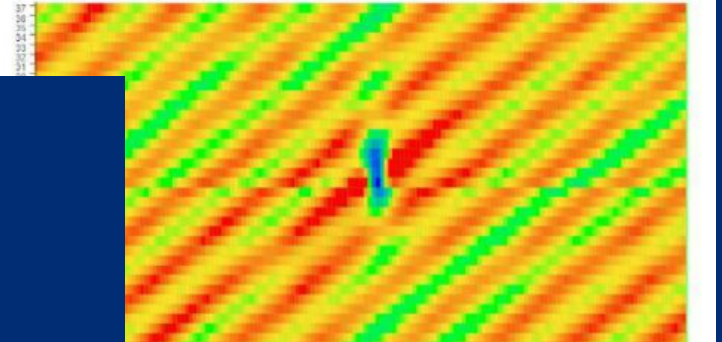
This groundbreaking technology modernizes Magnetic Rope Testing, ushering it into the digital era. The accompanying software assists our specialists in identifying potential anomalies. Thanks to in-depth analysis with features like heatmaps, it significantly enhances the accuracy of our assessments. Our digitized inspection data proves valuable in subsequent inspections, allowing for the recognition of damage trends over time.
